Anatomy of a Lightning Strike

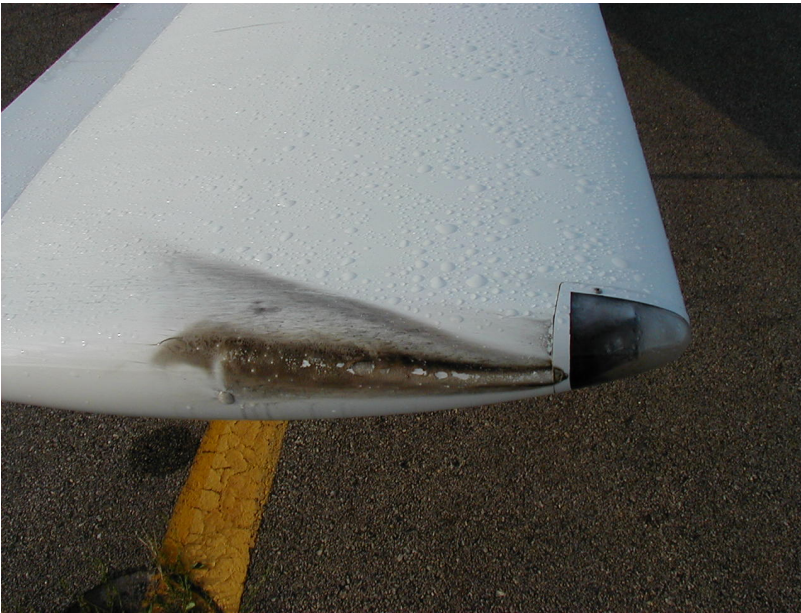
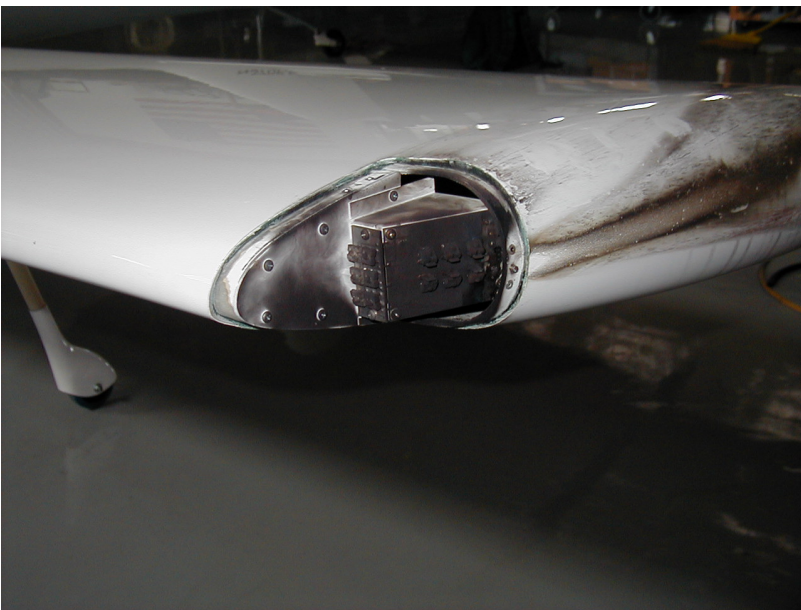
The panel went blank, and apart from the engine running things were quite. I looked out at both wings and saw long black training streaks on the tips. My first reaction was to check my 4 axis of control to ensure the aircraft was still flyable, which it was. I then surveyed the exterior for any other signs of damage, and none was evident. My next concern was electric fuel pumps continuing to run. I have my aircraft wired up with an E-Buss setup as described by Bob Knuckles of Aero Electric. In addition, one fuel pump is connected directly to the alternator so I turned on the E-Buss and GPS / Radio along with the transponder sprang into life but nothing much else. I press the "Nearest" function but the GPS seemed pretty confused so I dug out my hand held. As luck would have it I was only a few miles away from an airport and with over 8000' beneath me I knew I even with the engine out I was fine.

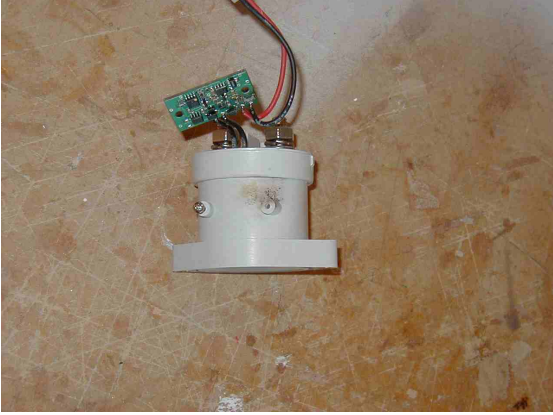
Main contactor

The main contactor was beyond repair so I replaced it with a prototype solid state unit from Eric Jones of <http://www.periheliondesign.com/> It also will be susceptible to large voltage spikes, but I am hoping that I won't get hit by lightning again. You can see in the photograph where the parts had vaporized and left burn marks on the casing.

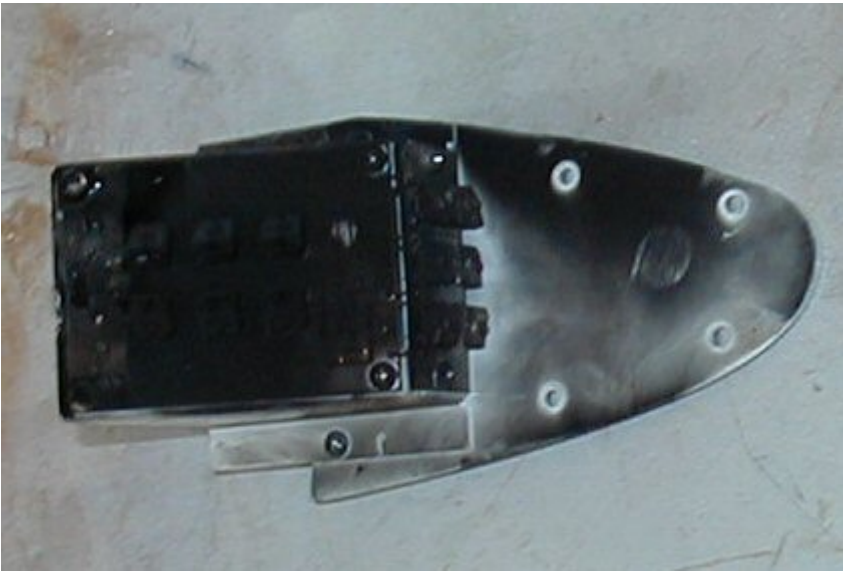
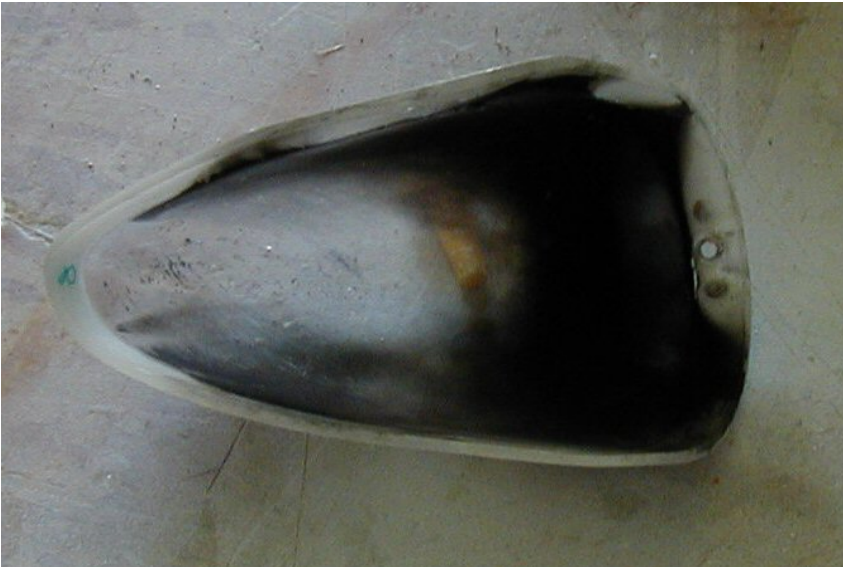
Wing tip lights

The wing tip lights are also made by Eric Jones of <http://www.periheliondesign.com/>. They were pretty vaporized so I bought some new ones. Quite a bit of the metal was deposited on the inside of the wing tip lens covers and I had to sand it off with wet and dry and re polish then with Mico Mesh.

The tail light LED was taken out as well, interestingly enough the 700 ma semiconductor current limit survived just fine, but on Eric's advice I replaced it as well.
